Kristall-Therme trimini in Kochel am See expanded with PCI products

A fairytale spa

Reference project

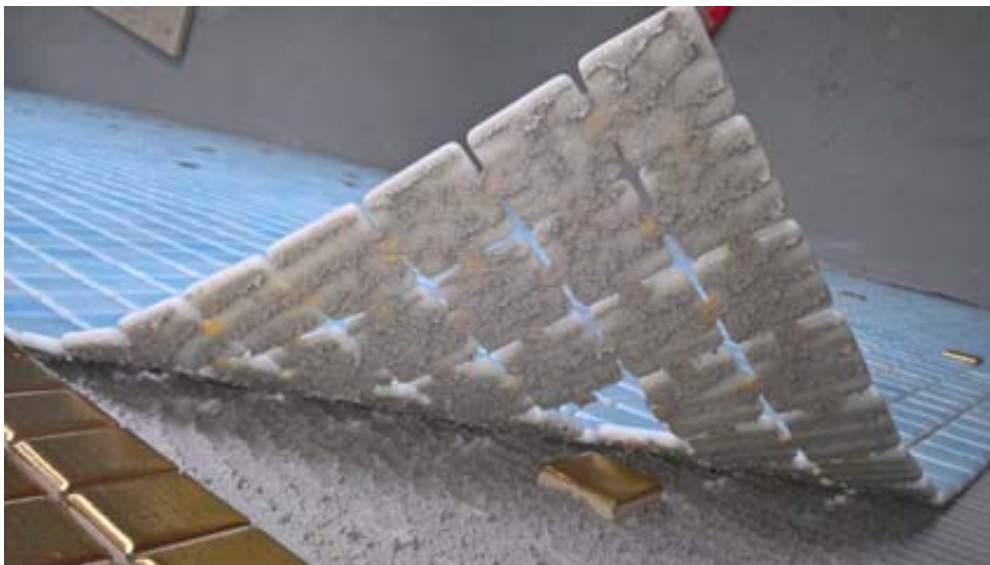
Fig. 5: For the laying of the mosaic tiling, the substrate was first levelled with PCI Pericret. The tiles were laid using PCI FT Klebemörtel mixed with PCI Lastoflex polymer-modified additive. In the soda pool, PCI Durapox NT plus reaction resin mortar was used for laying the glass mosaic tiling on glass-fibre-reinforced plastic waterproofing.

Mosaic tiling can only be laid on a substrate which has been properly prepared and is absolutely level. Initially, PCI carried out an adhesive tensile test to assess the strength of the concrete before it was approved for further work. After the surfaces had been cleaned using pressure cleaners, the tilers levelled the surfaces using PCI Pericret levelling compound. Mosaic tiling in the pool bar pool and tiles in all areas exposed to moisture were laid with PCI FT Klebemörtel mixed with PCI Lastoflex polymer-modified additive. The exclusive natural stone coverings in the sauna and wellness area were installed with PCI Carraflex flexible thin-based mortar which does not cause staining, even on sensitive marble. Tiling in the pools waterproofed with glass-fibre-reinforced plastic was laid with PCI Durapox NT reaction resin mortar.

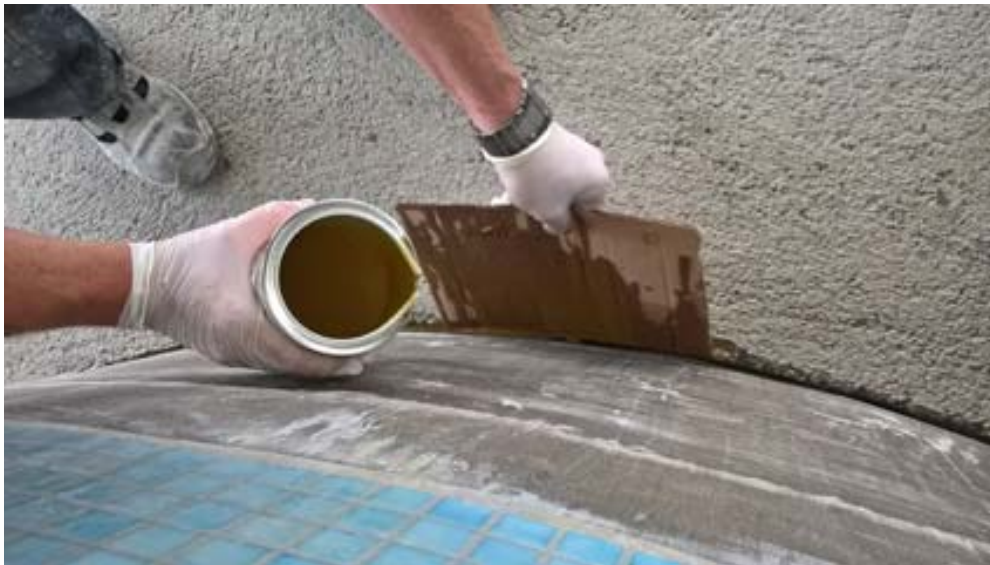
Fig. 6: Elastic grouting between the screed and the rising wall in the pool with PCI Apogel E.

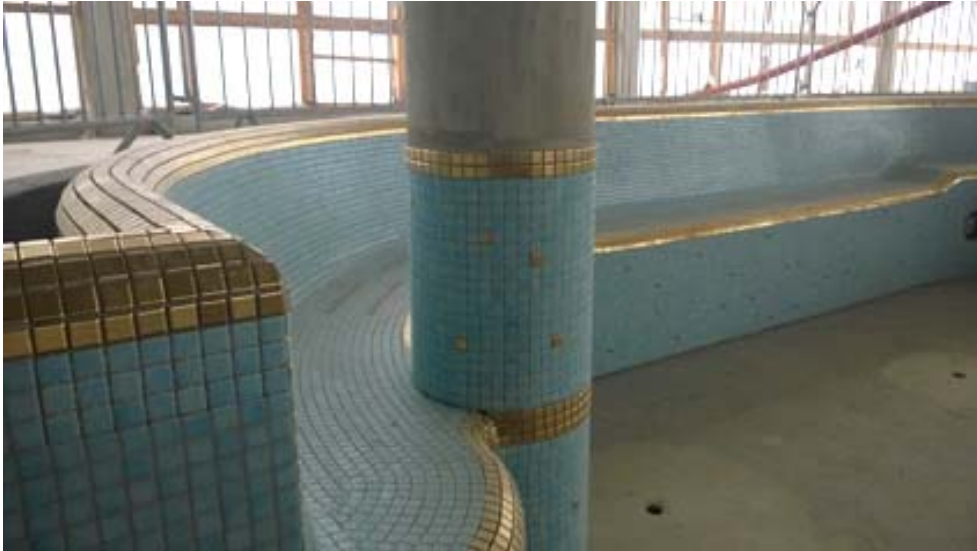
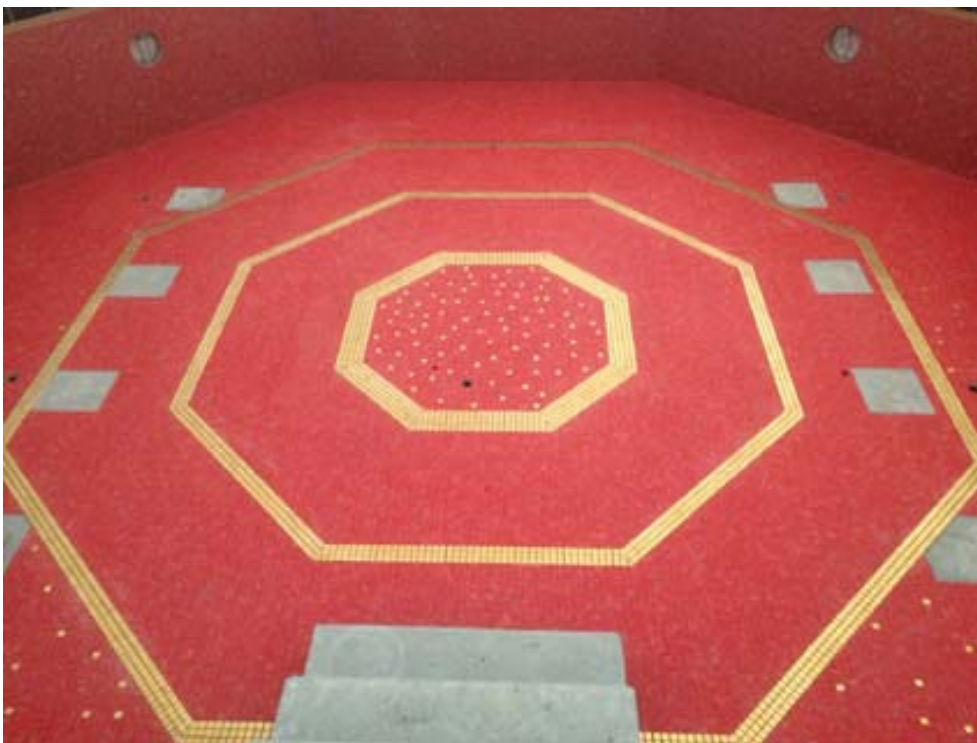
Fig. 7 and 8: The mosaic-lined pools of Kristall-Therme trimini create an exclusive and elegant impression. To ensure durable waterproofing, PCI Seccoral 2K Rapid fast-setting special waterproofing slurry was used.

At Kristall trimini, PCI Seccoral 2K Rapid fast-setting special waterproofing slurry was used for waterproofing the pool bar and the walls and floors of all areas exposed to moisture. PCI Seccoral 2K Rapid is suitable for exposure classes A and B in accordance with building standard list A, part 2/1.10 and for water exposure classes W0-I, W1-I, W2-I, W3-I in accordance with the new waterproofing standard DIN 18534 (waterproofing for indoor applications). Swimming pools and tanks are subject to DIN 18535. Like all PCI waterproofing products, PCI Seccoral 2K Rapid complies with the requirements of the new standards. The bonded waterproofing has isolating, stress-relieving and crack-bridging properties and therefore offers considerable security even if cracks occur at a later date. In hot tubs and other pools filled with water with added sodium bicarbonate, glass-fibre-reinforced plastic was used for waterproofing. In addition to the waterproofing work itself, it was necessary to ensure that the concrete covering reinforcement steel in the pool bar offered effective protection against corrosion. Where necessary, the thickness of the concrete was increased to the level required using PCI Nanocret R3 multi-use repair mortar.

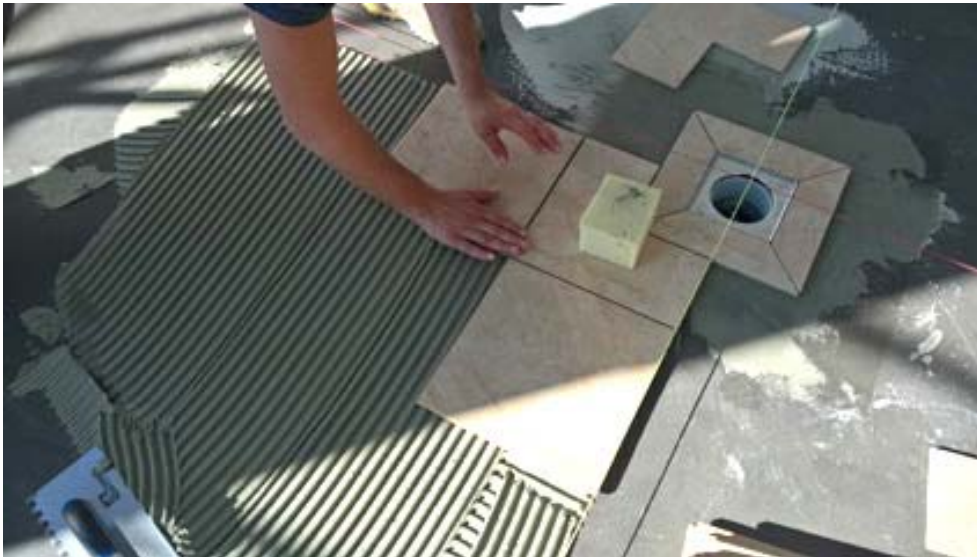
Fig. 9: The anti-slip tiling on the pool surrounds and in showers and changing rooms was laid using PCI FT Klebemörtel thin-bed adhesive with PCI Lastoflex polymer-modified additive.

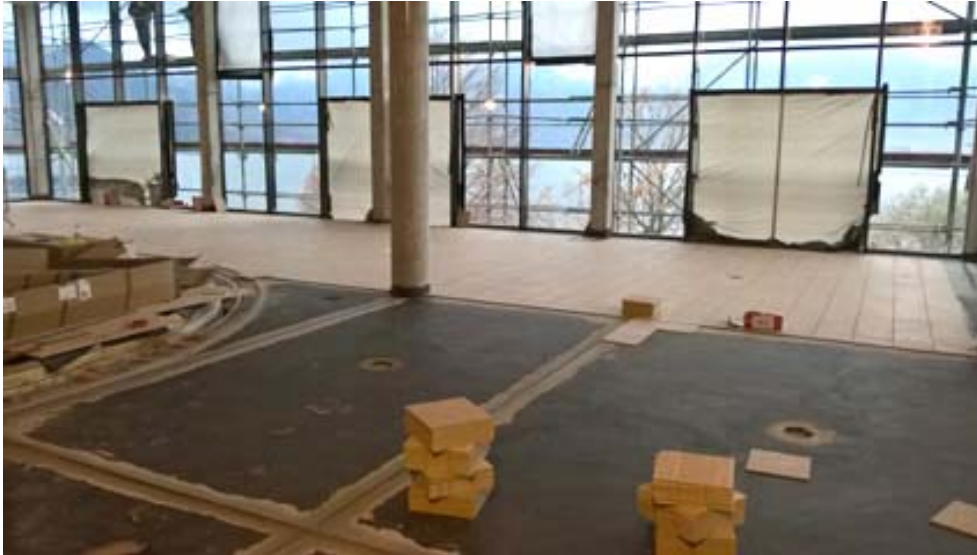
Fig. 10: The mosaic tiling of the pool was laid using PCI Durapox NT plus. This reaction resin mortar is especially well-suited for tiling exposed to chemicals, is wear-resistant, strong and insensitive to attack by swimming pool chemicals. PCI Durafug NT special cementitious joint grout was used for the pool surround.

The pools at Kristall trimini were grouted with PCI Durapox NT: this reaction resin mortar is especially well-suited for tiling exposed to chemicals, is wear-resistant, strong and insensitive to attack by swimming pool chemicals. Areas outside the pools were also grouted with PCI Durafug NT. The dense mortar structure of this special cementitious joint grout minimises the penetration depth of pollutants and ensures high strength. Thanks to Nanofill technology, PCI Durafug NT offers high resistance to mechanical stress and is also less vulnerable to attack by acidic cleaning products than conventional cementitious joint grouts. PCI Durafug NT is an element

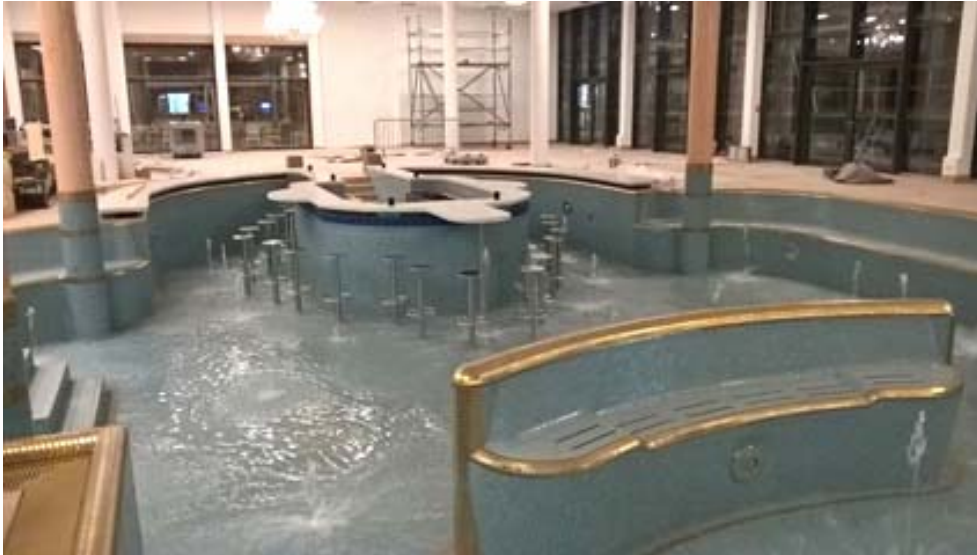
Fig. 11: Ready for the water. The tiling in the pool bar has been laid and grouted. Thanks to PCI Seccoral 2K Rapid, the substrate is absolutely watertight.
